1e. St Ann's Mill (SE 2645 3521) – Plan 5

Plan 5. St Ann's Mill – SE 2645 3521, 1:2500 (derived from WRRD 1920 66 1258 456).

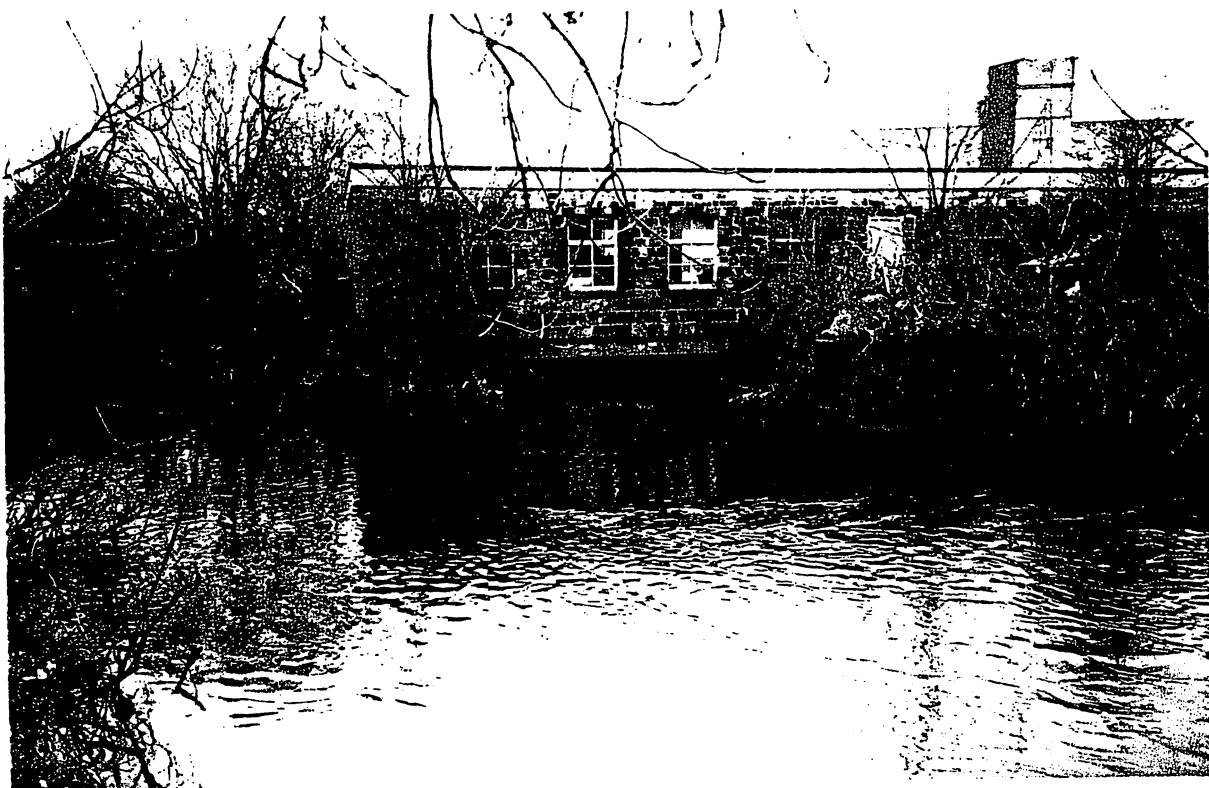
Water was supplied to the mill primarily from the Kirkstall Mill Race. However, this source appears to have been supplemented from the Aire by means of a short length of leat at SE 26425 35205 [47], which is taken off the river above a large weir at SE 2642 3517. The

47. St Ann's Mill, secondary leat entering main flow of Kirkstall Mill Race – looking east
west.

The lining of the water inlet from the river to the Kirkstall Mill Race at SE 25425 35205 is in a partial state of collapse, particularly marked at the confluence of the channel and the mill race. There is substantial intrusive plant growth in this area. Except for the missing coping stones noted above, the bridge related to this channel appears to be in a stable condition.

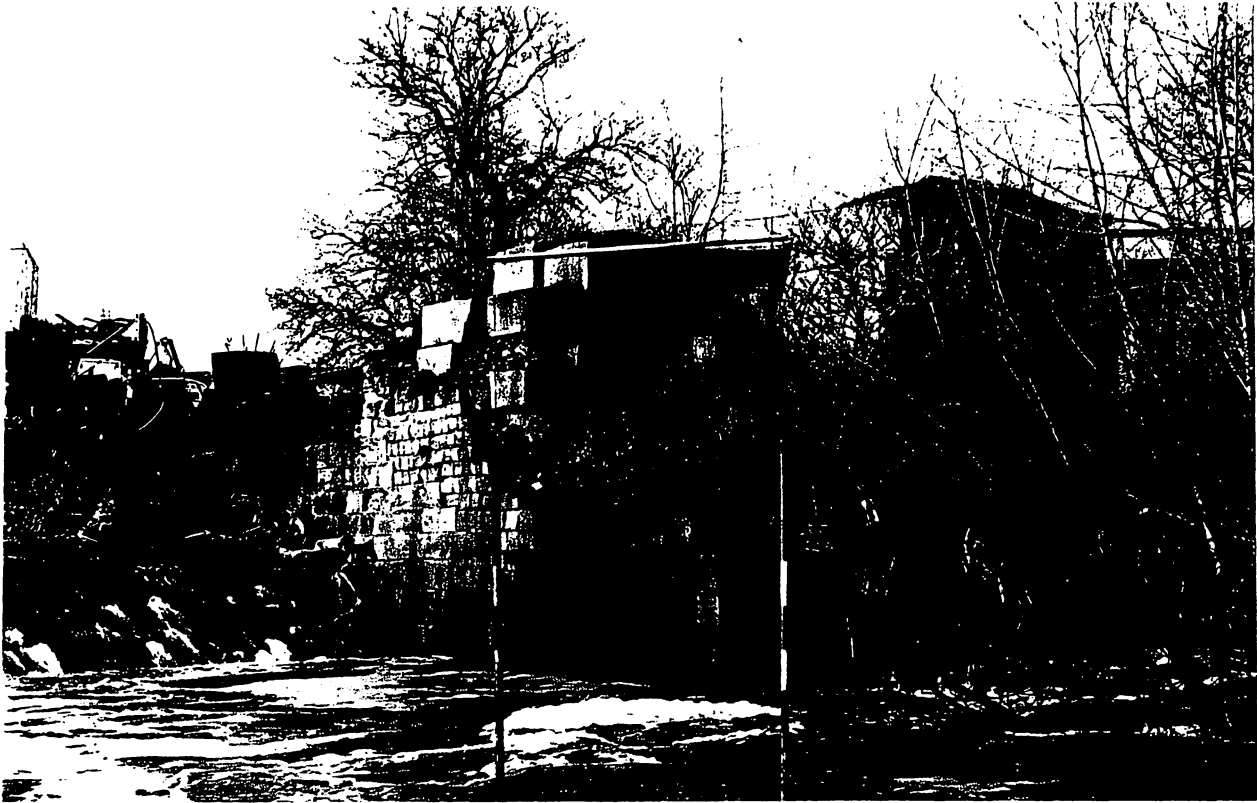
The eastern end of the river weir is anchored on what is effectively an island formed by this leat and the overflow channel to the south (see below). The west face of the island is revetted with large punch-dressed rectangular gritstone blocks, irregularly coursed [48]. This revetment is surmounted by several courses of smaller gritstone blocks, which may represent the remains of a contemporary structure. The weir curves into the flow of the river, and has an oblique air-face [49]. Air-face and curb appear to be constructed of rectangular masonry blocks. The river bank at the west end of the weir is revetted with large punch-dressed rectangular gritstone blocks, irregularly coursed [50, 51]. Some of the blocks appear to be margin dressed. This revetment is mirrored on the east side of the river by a mole separating the main flow of the river and that part of the Kirkstall Mill Race which acts as the tail race of the fulling mill [52, 53]. This mole is constructed in two sections, first, a shoulder of masonry abutting and projecting southward from the south-west corner of the mill building, and secondly a long, narrow wall projecting from this shoulder into the flow of the river. The masonry of the wall resembles that of the weir revetment on the west side of the river. The stonework is bound together with iron strapping, sealed with lead [54]. The masonry of the shoulder is of a similar fabric, but the blocks are slightly smaller and do not appear to be strap-bound.

48. *St Ann's Mill, revetment at east end of river weir – looking north. Note massive internal masonry of engine house surmounting revetment.*

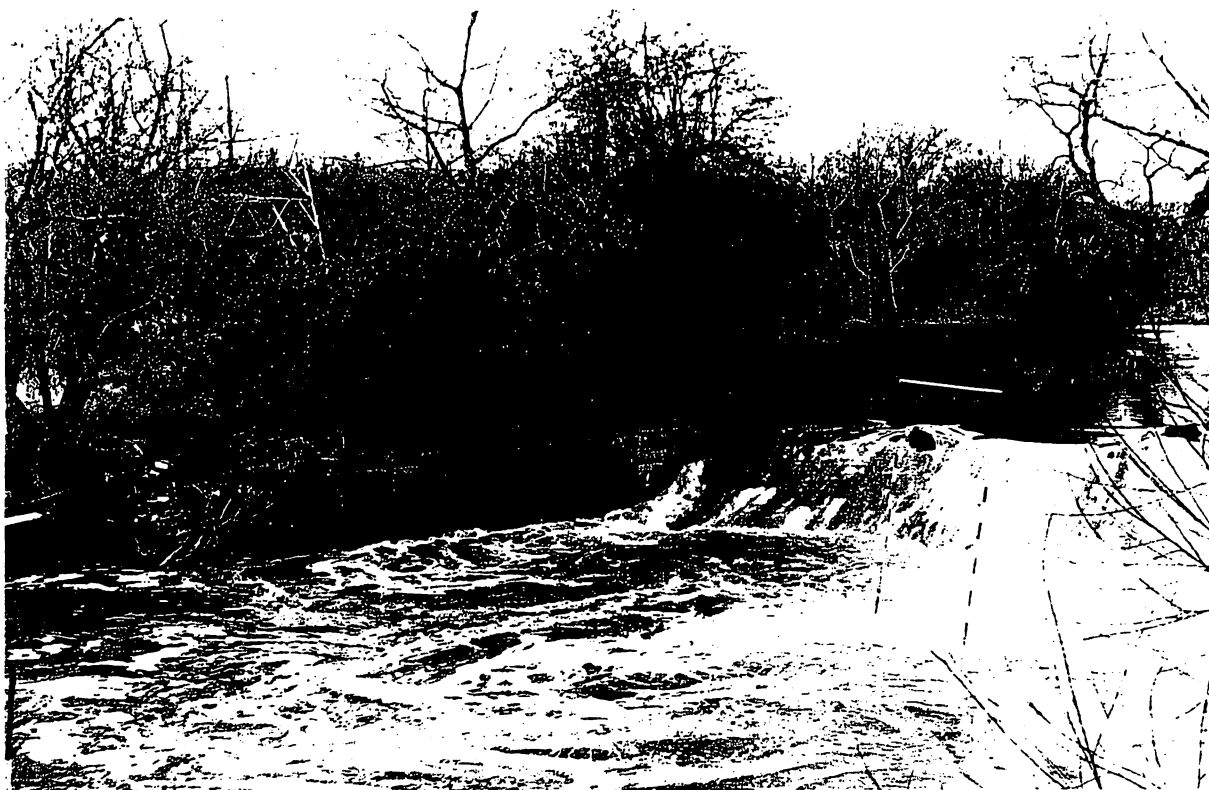
50. *St Ann's Mill, revetment of bank at west end of river weir – looking west.*

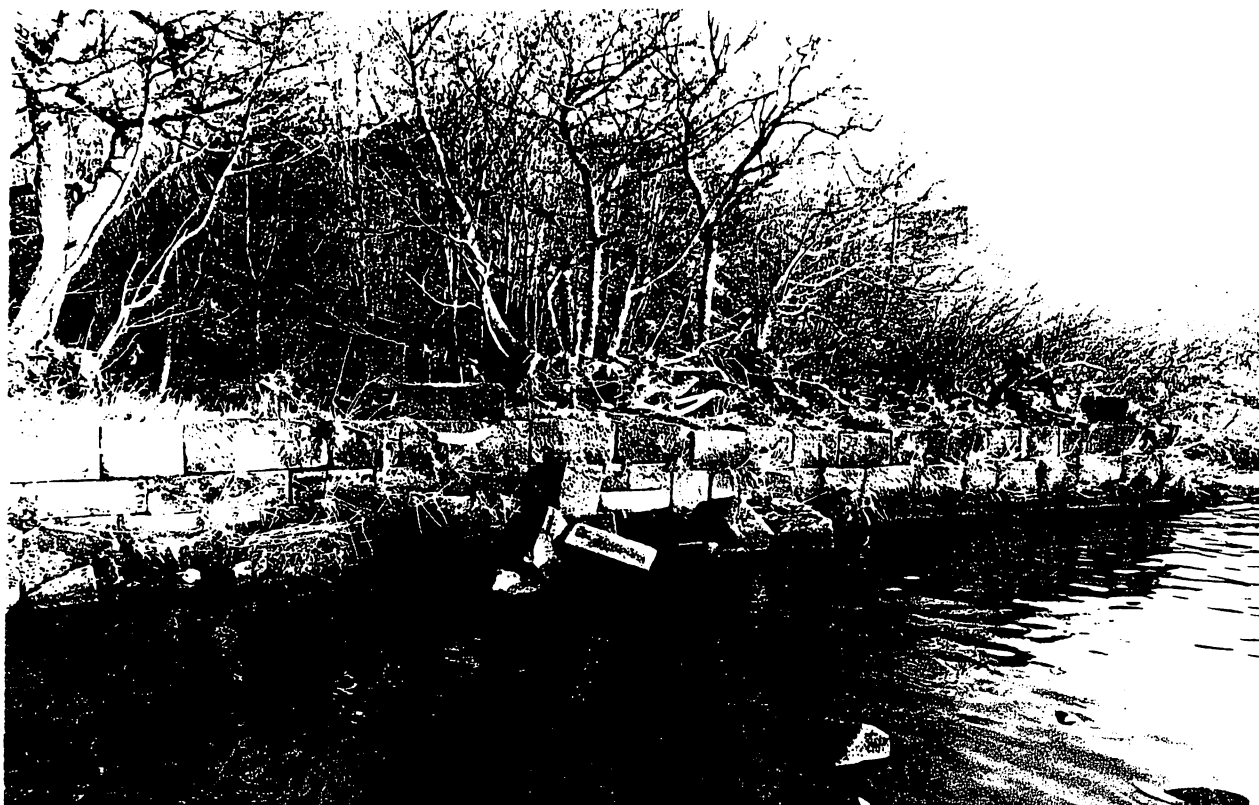
52. *St Ann's Mill, mole separating tail race and River Aire – looking east.*

The masonry mole to the south of the fulling mill has been colonised by saplings and now supports several mature trees, the roots of which are causing structural damage.
