1e. St Ann's Mill (SE 2645 3521) – Plan 5

Plan 5. St Ann's Mill – SE 2645 3521, 1:2500 (derived from WRRD 1920 66 1258 456).

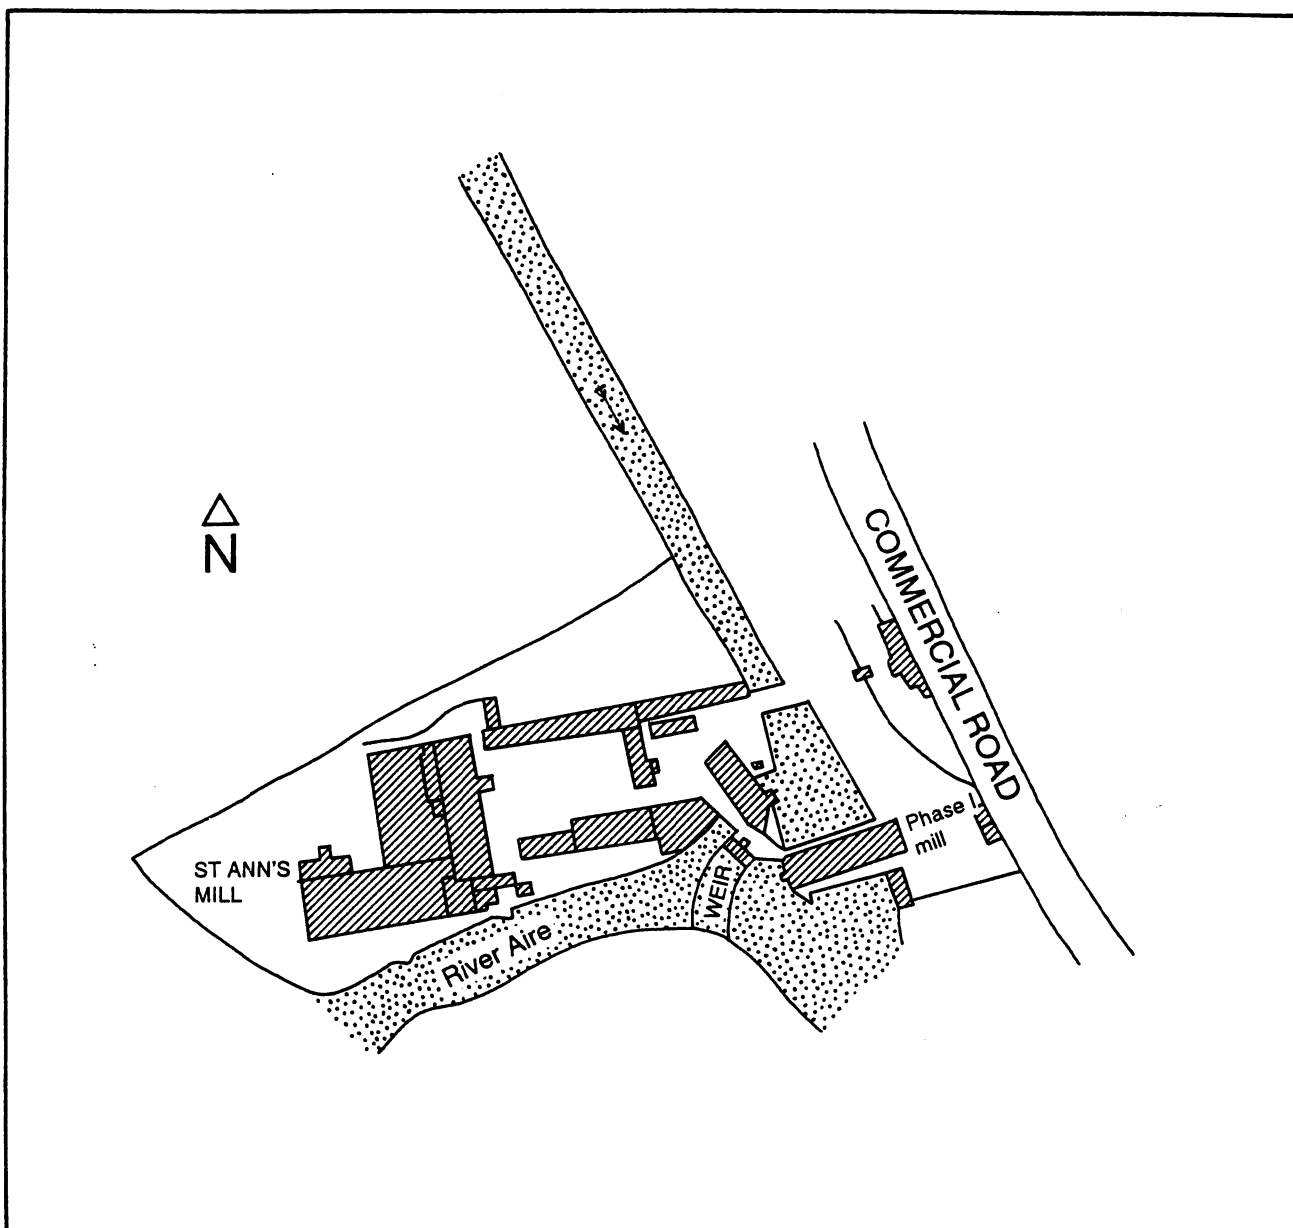
There are three major features, or groups of features, still extant which can be positively identified with structures on the 1822 map. The first is the bridge which carries the entrance road to the site over the leat at SE 2643 3524. The second is the mill building, now of three storeys, with central clock tower, which sustained major fire damage in the 1980s (SE 2633 3520). The third consists of the group of features centred at SE 2644 3519, comprising a watermill (now represented only by foundations at SE 2646 3519) and related water management features. The remains of an engine house contained within this last group, although not positively identifiable on the Thorpe map, probably pre-dates its publication. Although all of the features detailed are present on site by 1822, examination of the masonry demonstrates at least two distinct phases of development which had taken place prior to that date. These can be tentatively identified as follows.
